Aviation Safety

Letter

Issue 3/2001

Destination, destination, destination!

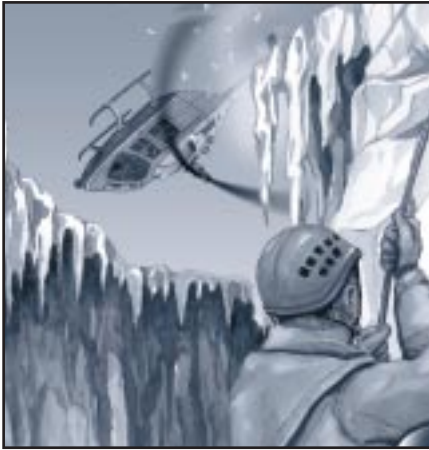
Helicopter Collides with Glacier

On June 22, 2000, the pilot of a Bell 206L-3 helicopter was conducting filming operations at the Llewellyn Glacier for a television commercial depicting extreme sports. The helicopter, equipped with a nose-mounted camera, was occupied by the pilot, the film director, and two camera operators. The helicopter was flying at a high speed in a crevasse among seracs on the glacier when its main rotor struck a serac. Seracs are castle-like masses into which a glacier is divided at steep points by crossing crevasses. The main rotor broke, and the helicopter careened into the ice wall of a perpendicular crevasse, broke apart, caught fire, and tumbled into the crevasse. The impact forces were not survivable, and the remains of the main fuselage area were not recognizable. Rescue and recovery personnel determined that there were no survivors and that recovery would present a high risk to personnel. There was no recovery. This synopsis is based on the Transportation Safety Board of Canada (TSB) Final Report A00P0107.

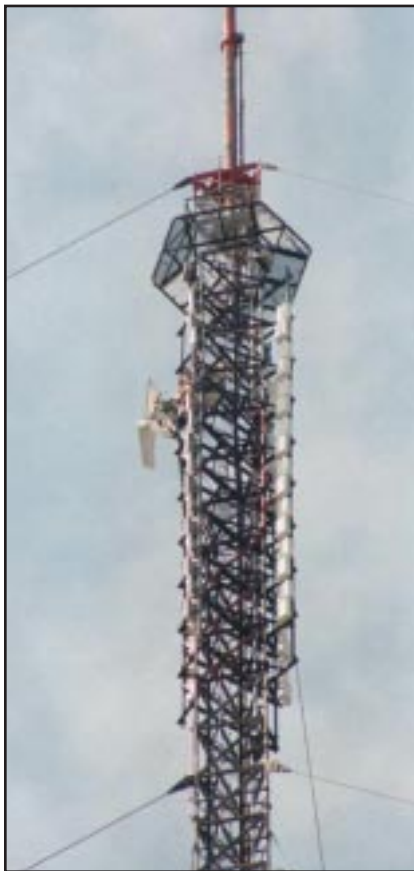
Collision with Tower

On April 22, 2001, a Cessna 150 collided with a very high communication tower on Mont-Carmel, near Shawinigan, Que. The flight was conducted under visual flight rules (VFR). Around 9:15, witnesses near the accident scene heard the noise of an aircraft engine, followed by an impact noise. The pilot, alone on

board, was killed. The weather conditions cleared up at around 11:00, allowing the rescuers to locate the aircraft, which was embedded in the metallic tower structure at about 950 ft AGL. The collision caused structural damage to the tower, and rescuers were unable to reach the wreckage. Consequently, the aircraft and the pilot were not recovered until a few days later, when the local authorities were forced to destroy the tower.

Several lessons can be drawn from this accident, particularly concerning pre-flight planning, VFR flight into deteriorating weather, and pilot decision making (PDM). VFR navigation flight requires an exhaustive review of the weather conditions and of the planned route on the appropriate VFR navigation charts. We need to identify all significant obstacles along the route and all the maximum elevation figures (MEF). These are shown in quadrangles bounded by dashed lines of latitude and longitude, and they indicate the highest terrain elevation plus 328 ft (100 m) or the highest known obstruction elevation, whichever is higher. Therefore, current and forecast weather conditions should always allow you to fly in VFR conditions above all the MEFs along your route. Finally, this accident may be an appropriate case study for your next PDM class. △
